**Management of inadequate tooth structure in order
to accomplish predictable prosthetic dentistry**

Functional Crown Lengthening

Drs. Alan Rosenfeld and George Mandelaris
Diplomates, American Board of Periodontology

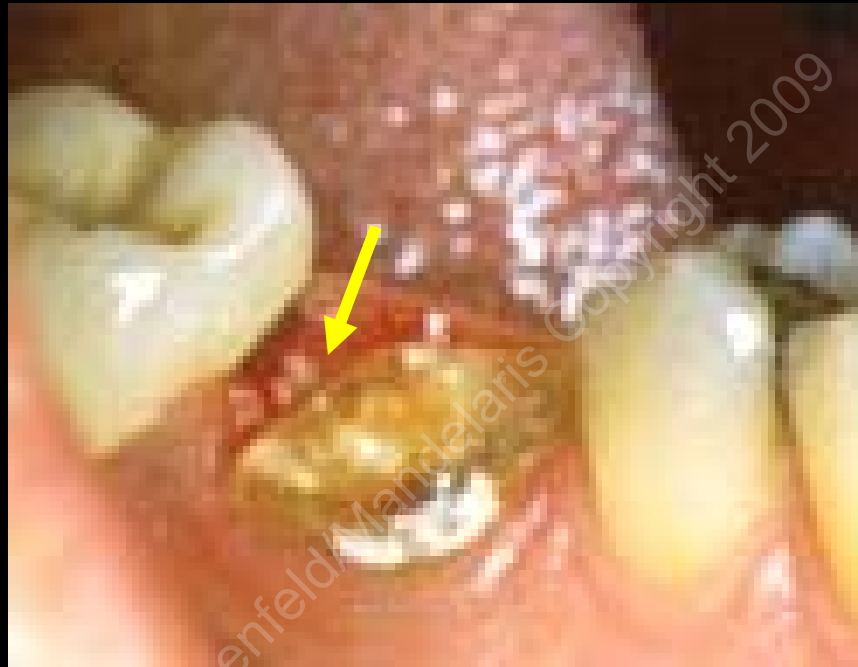
Inadequate tooth structure for a crown

- This photo shows a tooth that has fractured at the gum line. Clinical and Radiographic examination have determined that this tooth can be saved, but will need a crown. In order to provide the restorative dentist with sufficient tooth structure to which a crown can attach, functional crown lengthening periodontal surgery will need to be performed. This surgery is performed to lower the gum and bone levels thereby exposing more tooth structure.

- Also noted is the inflammation that has occurred around the gum tissue attaching to the tooth. This is called **biologic width violation (yellow arrow)** and can not be tolerated by the body. It results in red, bleeding gums (i.e. inflammation) which will not go away by excellent brushing and flossing. Crown lengthening surgery will also negate biologic width violation in the final crown, another added benefit.

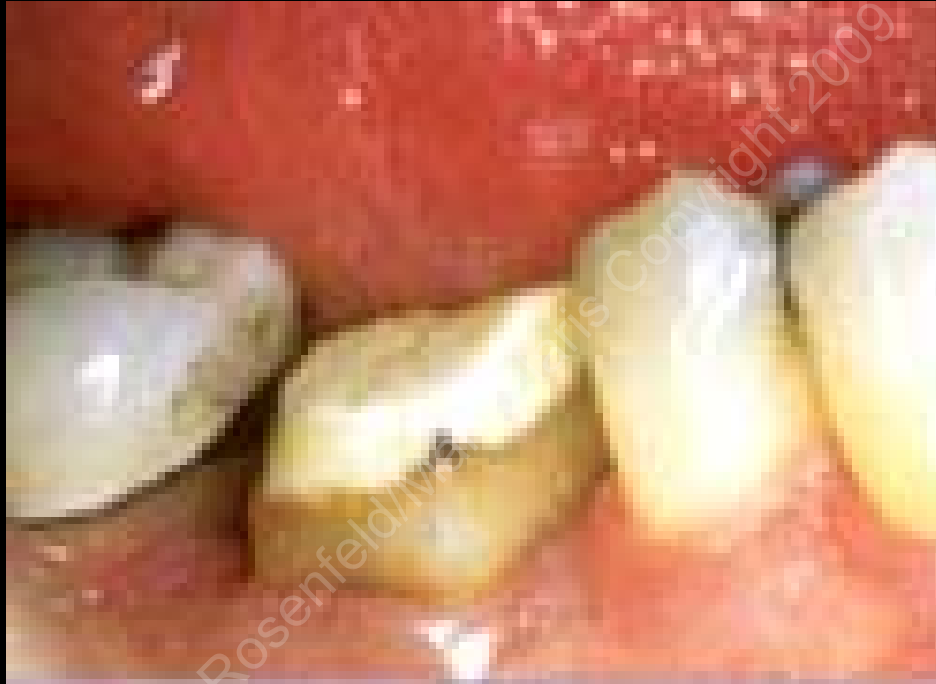
Inadequate tooth structure for a crown

- This photo shows the tooth after functional crown lengthening surgery. The surgery has successfully accomplished exposure of more tooth structure to which the dentist has sufficient retention and resistance form for a crown.
- In addition, the longer/more exposed tooth structure allows the dentist to place the crown margin above the gum line so as not to impinge on the healthy and natural occurring gum seal around the tooth (i.e. the biologic width attachment).
